# Interpreted Investigation Report: Loss of Vikram Lander During Lunar Landing Phase

**Abstract:** This article examines India's first science lander mission on 22 July 2019, attempting a historic landing on the Lunar South Pole Region. Communication was lost at 2.1 km above the lunar surface during the rough braking phase. The cause of the Chandrayaan 2 lander "Vikram" failure remains undisclosed. Possible factors such as vibrations, thruster issues, and power depletion are considered. Recommendations include backup power sources and direct communication systems for interplanetary missions. Despite the setback, ISRO proposed "Chandrayaan 3" to explore the lunar polar region. Chandrayaan 2's legacy influences future missions, shaping India's aspirations for pioneering space endeavors. Gratitude is expressed to ISRO for insights gained during live coverage.

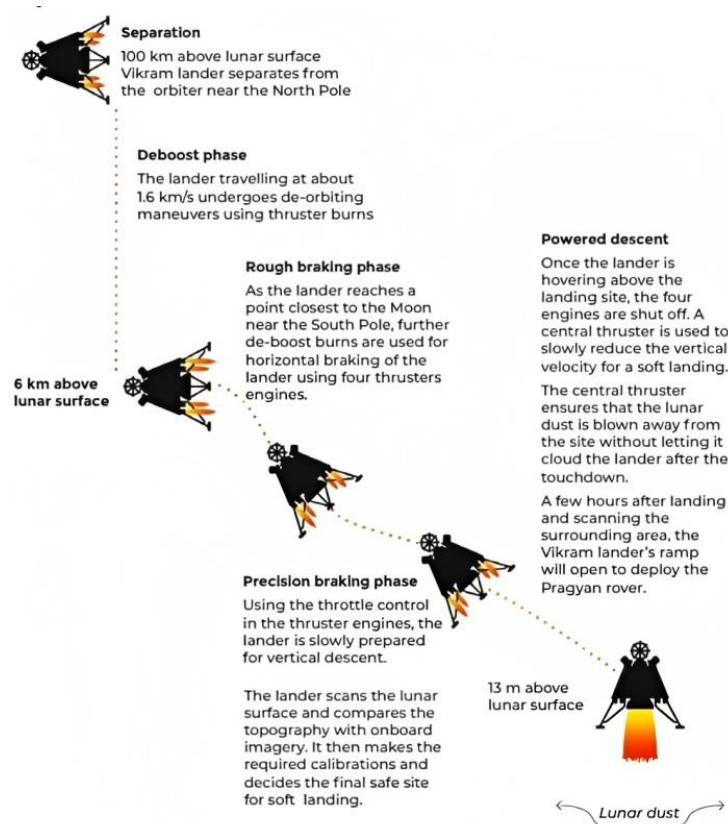
**Figure 1 Vikram Lander's Landing Sequence [Courtesy: ISRO]**

The detailed sequence of the Vikram lander's landing process is depicted in Figure 1. Subsequent to the landing attempt, efforts were undertaken to locate the impact site of the lander. It was Shanmuga Subramanian who first reported notable changes in lunar surface activity, ultimately aiding in the identification of the lander and its impact site by NASA. The crash site of the lander was determined to be at coordinates 70.8810°S, 22.7840°E, with an elevation of 834 meters (Source: NASA), as illustrated in Figure 3 [1].

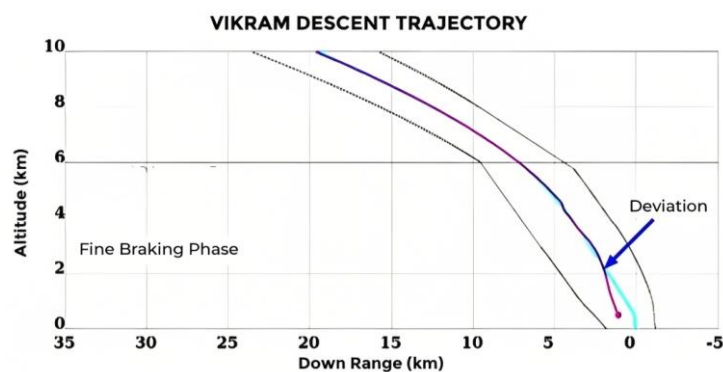
**Figure 2 Vikram Lander's Trajectory [Courtesy: ISRO]**

- At the juncture where a trajectory graph indicates a deviation, it's conceivable that the cessation of thruster activity or incorrect firing of descent thrusts might have led to the spacecraft's loss of control over its orientation. This, in turn, could have resulted in the crash of the lander onto the lunar surface.
