# Feasibility of Emergency IVA Spacesuit Bladder Repair During Parabolic Microgravity Flight

Jenee' Fox

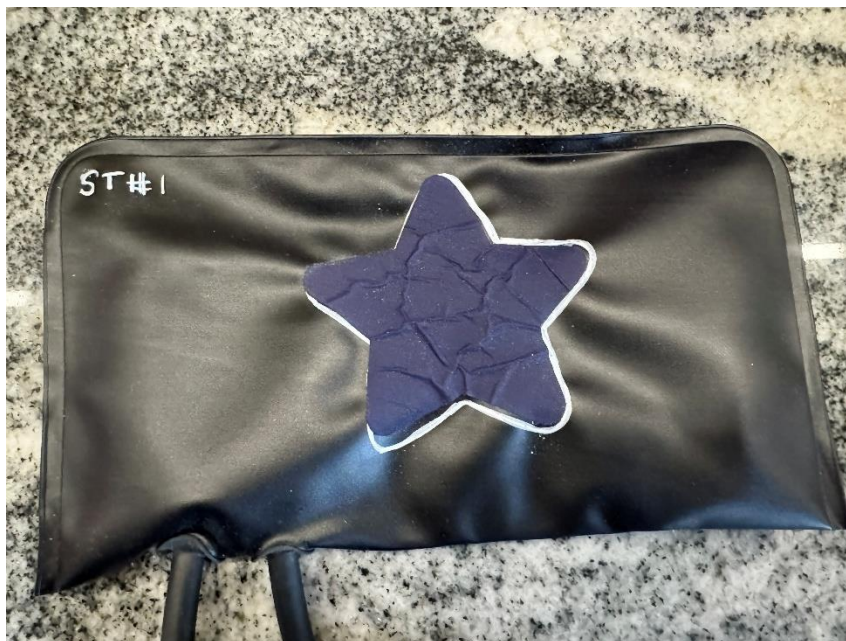
**Figure 5A. Star Patch Trial SP-1**

Representative repair outcome for Star Patch Trial 1. Minor adhesive gathering and slight placement deviation were observed; however, the repair maintained a complete seal at 6 psi.

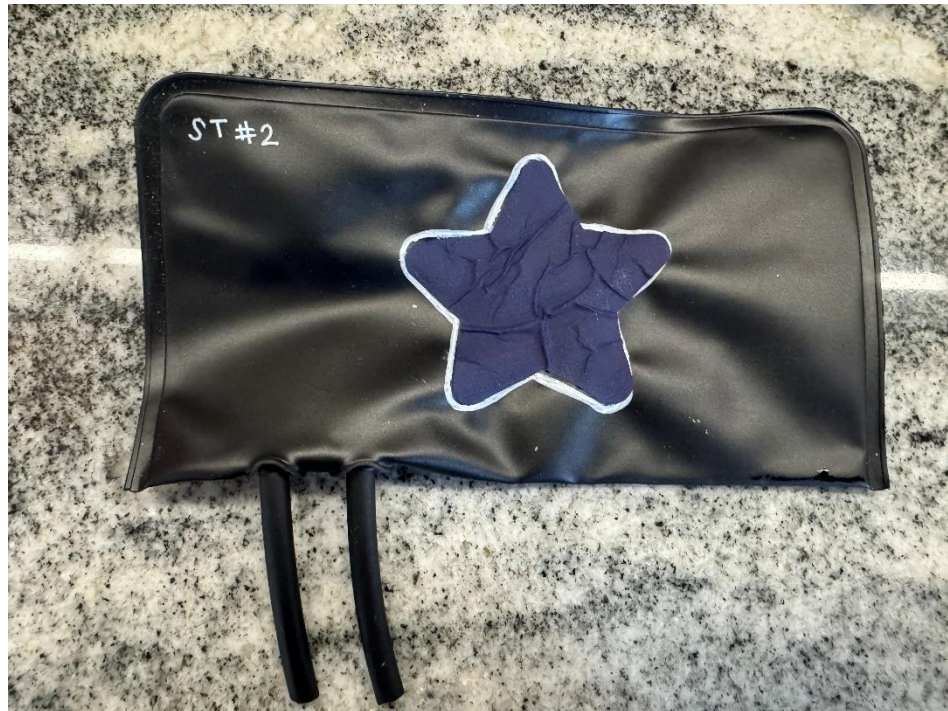
**Figure 5B. Star Patch Trial SP-2**

Representative repair outcome for Star Patch Trial 2. Minor adhesive gathering was observed on one star point. The repair maintained complete pressure retention at 6 psi.

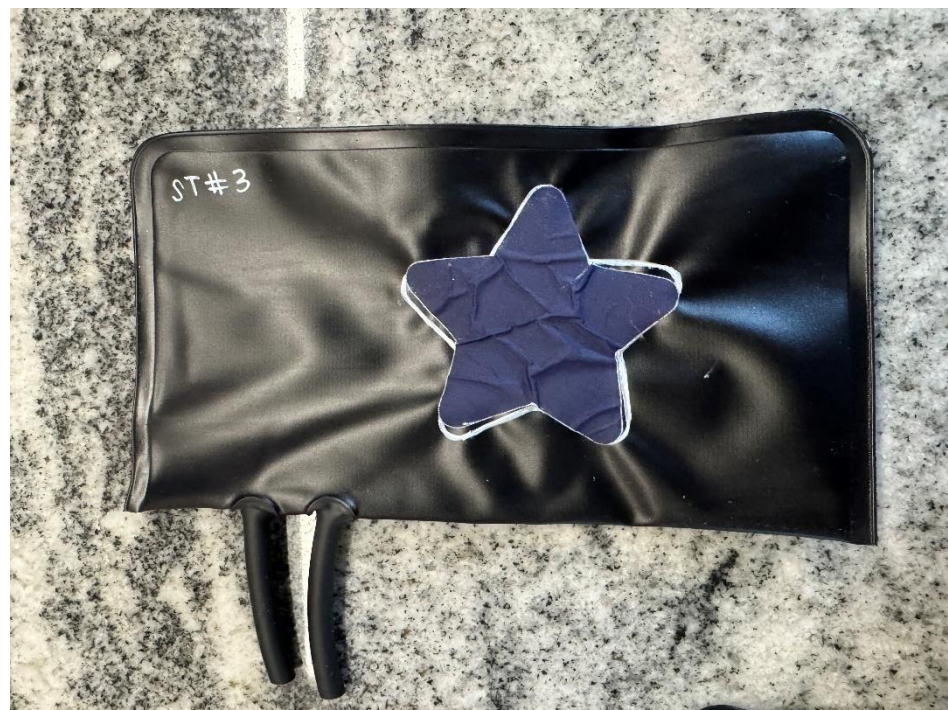
**Figure 5C. Star Patch Trial SP-3**

Representative repair outcome for Star Patch Trial 3. Multiple point misalignment was observed during application. Although the bladder reached 6 psi, audible leakage was present and continuous pressure was required to maintain inflation.

| Trial | Repair Method | Alignment / Application Notes | Observed Issue | Outcome | Pressure Result |
|---|---|---|---|---|---|
| SP-3 | Star patch | 1/8 in. misalignment on four star points | Distractions included floating water bottle and emesis bag; audible hissing leak present | Partial seal | Reached 6 psi only with constant pressure |

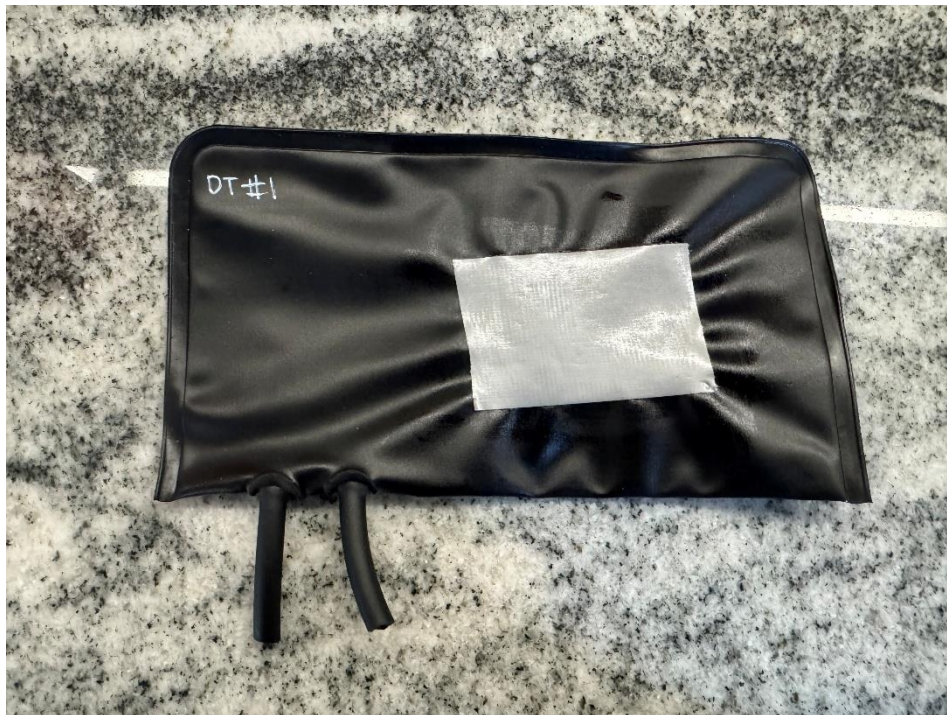
**Figure 6A. Duct-tape repair outcome for Trial DT-1.**

Visual inspection of the repair trials identified localized rippling of the bladder analog beneath the duct-tape repairs during Trials DT-1 and DT-3. These ripples coincided with partial seal performance despite proper repair alignment. Trial DT-2 did not exhibit observable rippling and maintained complete pressure retention. A representative duct-tape repair configuration evaluated during active microgravity exposure is shown in Figure 6.

Representative duct-tape repair applied during active microgravity operations. Although the repair was properly aligned and the bladder achieved the target pressure of 6 psi, rippling of the underlying bladder material created leakage pathways beneath the repair. Continuous pressurization was required to maintain inflation, resulting in classification as a partial seal.

| Trial | Repair Method | Alignment / Application Notes | Observed Issue | Outcome | Pressure Result |
|---|---|---|---|---|---|
| DT-1 | Duct tape | Properly aligned; tape cut with teeth during parabola | Ripples in bladder material beneath tape created leak paths | Partial seal | Reached 6 psi only with constant pressure |

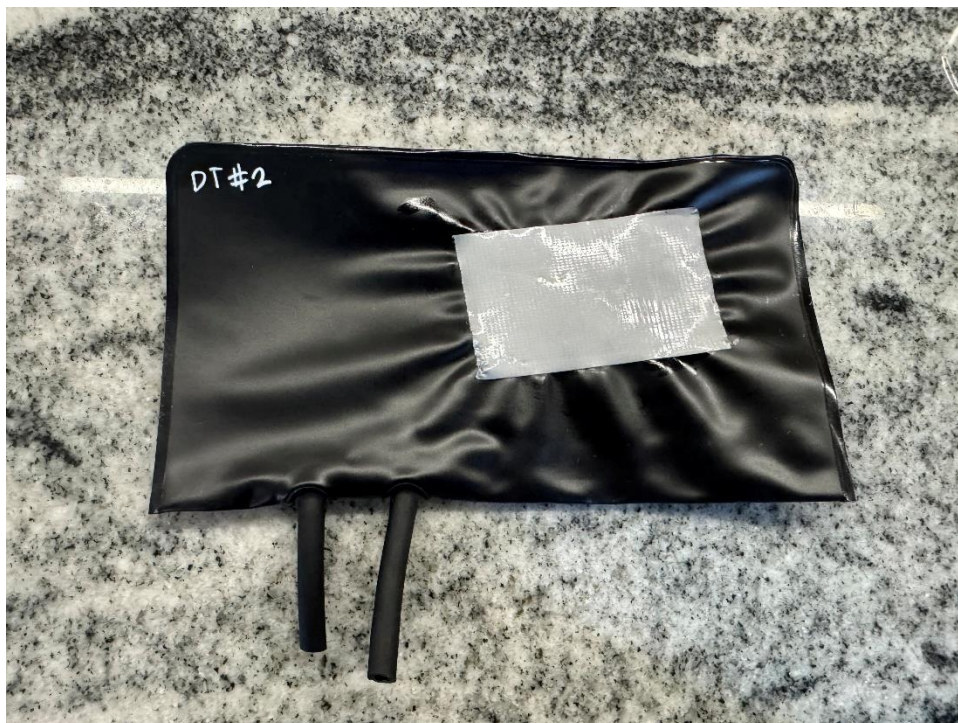
**Figure 6B. Duct-tape repair outcome for Trial DT-2.**

Representative duct-tape repair demonstrating complete seal performance during microgravity testing. The repair was properly aligned, exhibited no observable wrinkle formation beneath the adhesive surface, and maintained pressure at 6 psi without requiring continuous pressurization. This trial represented the highest-performing primary duct-tape repair outcome observed during the investigation.

| Trial | Repair Method | Alignment / Application Notes | Observed Issue | Outcome | Pressure Result |
|---|---|---|---|---|---|
| DT-2 | Duct tape | Properly aligned; tape cut with teeth during parabola | No observed leak | Full seal | Held 6 psi |

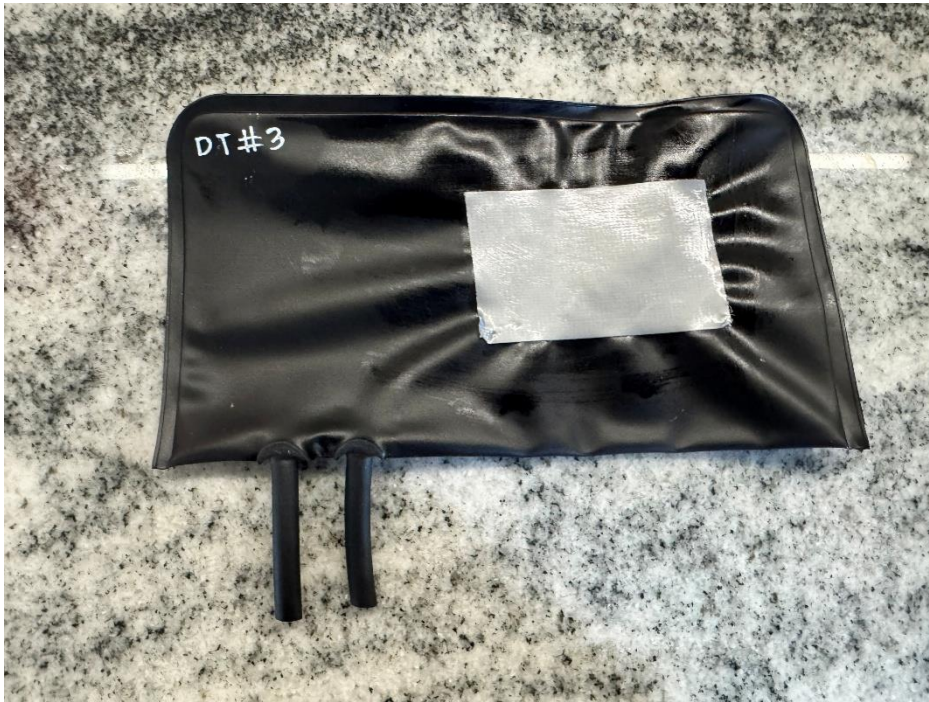
**Figure 6C. Duct-tape repair outcome for Trial DT-3.**

During the third duct-tape repair parabola, wrinkle formation was identified following the initial adhesive application. The repair material was removed and reapplied during the same parabola, resulting in successful temporary seal formation prior to the conclusion of the microgravity interval.

Representative duct-tape repair demonstrating wrinkle-induced leakage during microgravity operations. Although the repair was properly aligned and achieved 6 psi, deformation of the bladder material beneath the repair created leak pathways that prevented complete pressure retention. Continuous pressurization was required to maintain inflation, resulting in classification as a partial seal.
