# Feasibility of Emergency IVA Spacesuit Bladder Repair During Parabolic Microgravity Flight

Jenee' Fox

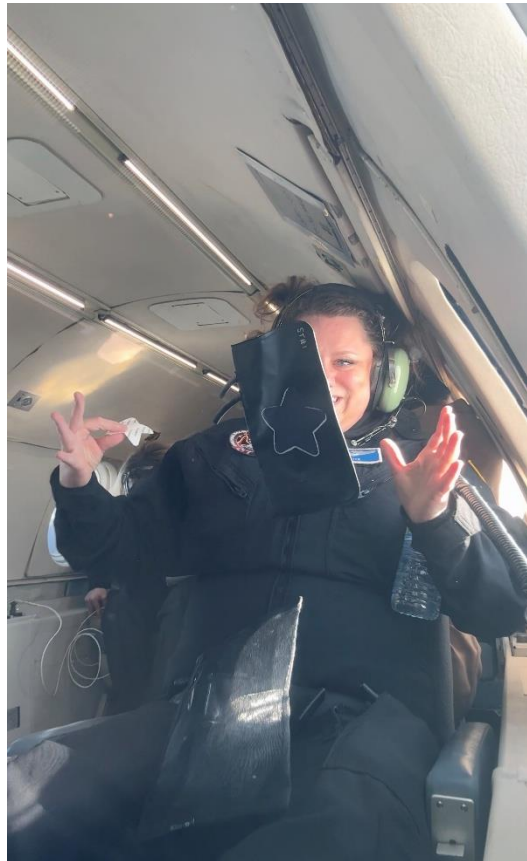
**Figure 4. Representative microgravity repair environment during parabolic flight testing with Jenee' Fox.**

Representative operational conditions observed during repair activities are shown in Figure 4. Free-floating objects, including a water bottle and repair materials, frequently drifted within the operator's workspace and occasionally competed for attention during repair deployment.

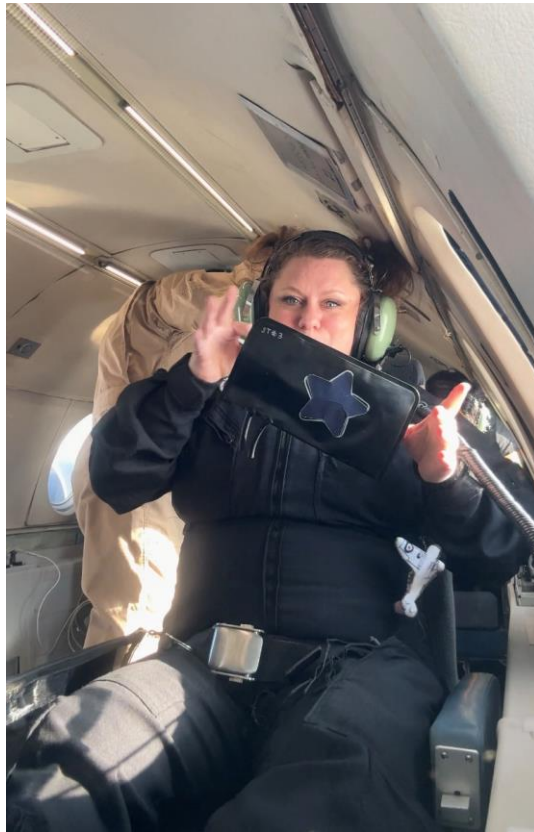
**Figure 5. Star-shaped adhesive repair evaluation during active microgravity exposure, Jenee' Fox.**

Modified star-shaped adhesive repair patches achieved pressure containment in all three dedicated repair parabolas. Two of the three trials achieved complete pressure retention without continuous pressurization, while the third achieved partial seal performance due to audible leakage associated with patch misalignment and operational distractions during microgravity exposure. Successful seal formation was achieved even in cases of imperfect operator alignment during application. Across the three primary star-shaped repair trials, two maintained complete pressure retention without continuous pressurization, while one exhibited audible leakage following application. Minor adhesive gathering and placement deviations were observed during successful repairs, whereas greater misalignment was associated with partial seal performance.

Representative star-patch repair configuration following application to the flexible bladder analog during a microgravity parabola. The figure illustrates adhesive placement, seal formation, and wrinkle characteristics observed during the repair evaluation. A representative star-shaped repair application during microgravity testing is shown in Figure 5. Visual observations documented minor adhesive gathering, placement variability, wrinkle formation, and overall seal performance during repair deployment. Complete pressure retention was maintained in two of the three primary star-shaped repair trials. Across the three primary star-shaped repair trials, the modified repair configuration produced two complete pressure-retention outcomes and one partial seal.

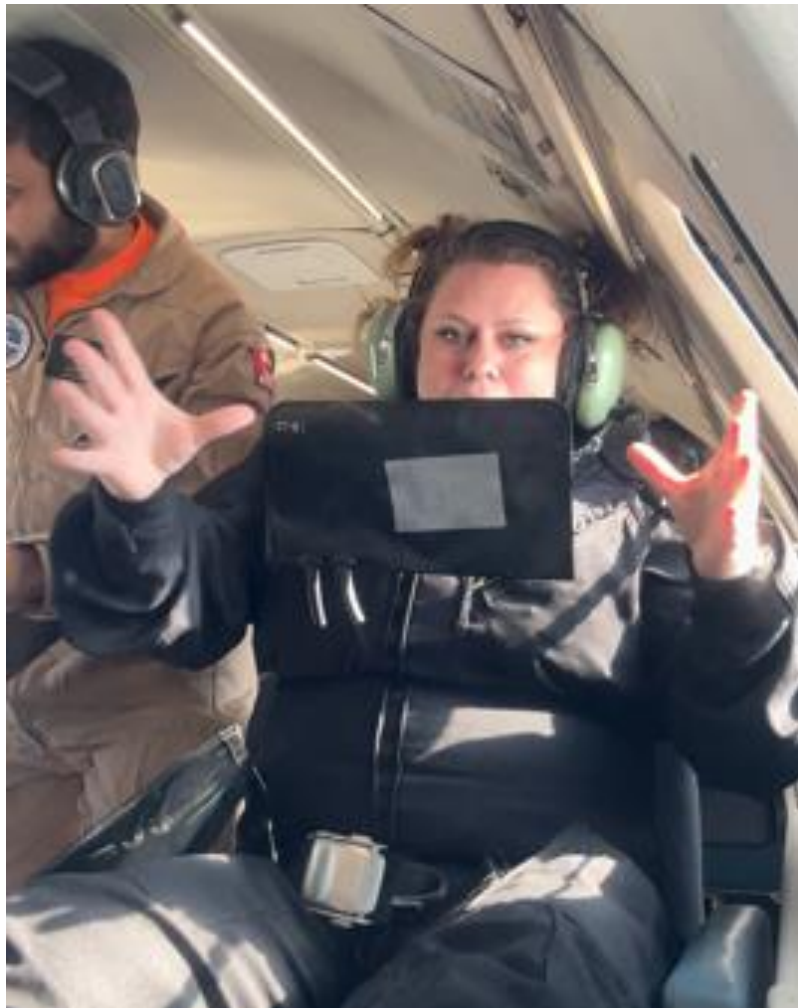
**Figure 6. Duct-tape repair assembly during parabolic microgravity flight, Jenee' Fox.**

Duct-tape-style repair methods demonstrated less consistent seal performance during microgravity operations despite offering advantages in rapid accessibility and simplified deployment. One duct tape repair failed to maintain a complete seal throughout the duration of the parabola. A second repair achieved only partial seal integrity during the microgravity interval. During the third dedicated duct tape repair parabola, the initial repair application produced observable wrinkle formation within the flexible bladder analog material, negatively affecting conformity around the puncture region and preventing complete seal formation. The repair material was subsequently removed and reapplied during the same parabola. Following reapplication, a successful temporary seal was achieved prior to the conclusion of the microgravity interval.

Visual inspection of the repair trials identified localized rippling of the bladder analog beneath the duct-tape repairs during Trials DT-1 and DT-3. These ripples coincided with partial seal performance despite proper repair alignment. Trial DT-2 did not exhibit observable rippling and maintained complete pressure retention. A representative duct-tape repair configuration evaluated during active microgravity exposure is shown in Figure 6.
